# ***Nash-Healey***

**APRIL 30, 2011**

## **TECHNICAL BULLETIN**

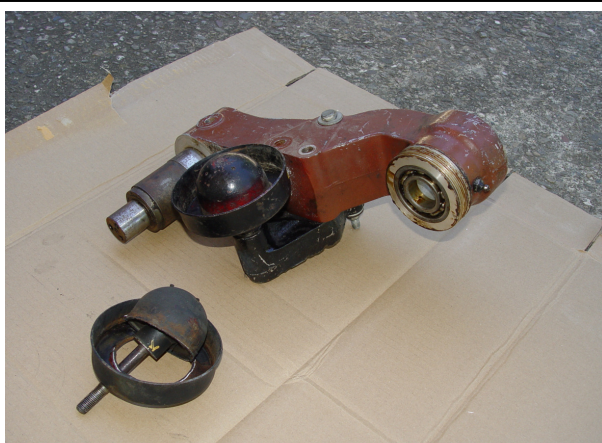
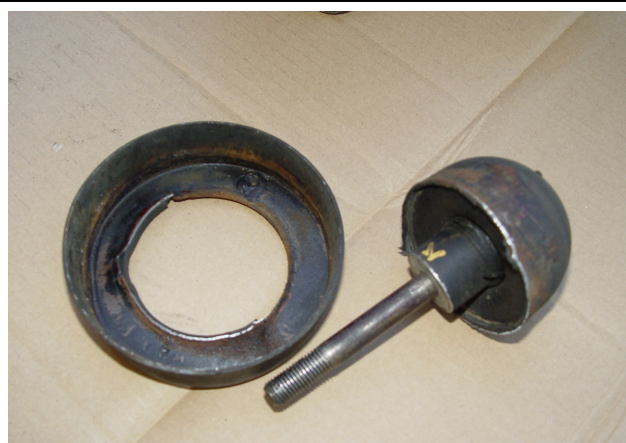
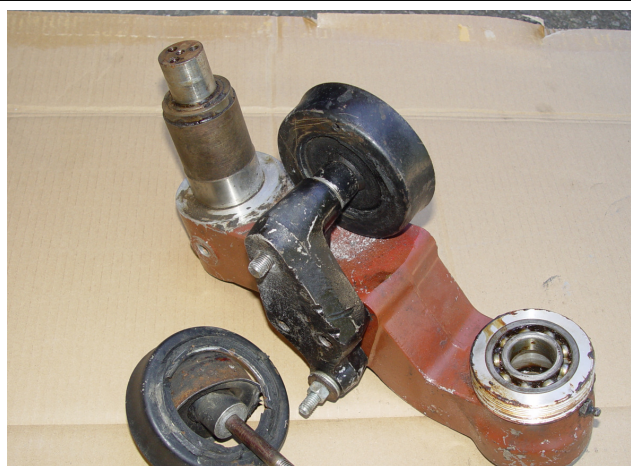
I just wanted to give you a heads up on a potential front suspension failure that could be catastrophic. I have attached three photos of the lower coil spring seat and jounce bumper assembly. In the NH parts book it is part number 311 4895 and called a "Seat, Front Coil Spring (lower)". In these photos I have shown a lower trailing link assembly with a good spring seat attached, a good used spring seat and the failed part.

The part in question is stamped steel and the actual spring seat and the jounce bumper housing is formed in a single piece. The attaching stud with a ball on the top is then held inside the steel jounce bumper housing and lastly it is poured full of rubber. Where the bottom of the jounce bumper housing is formed into the spring seat the steel thickness is compromised by the 90 degree bend to form the seat and that is the point of failure.

On this car the seat failed at that 90 degree bend and dropped the spring and seat down onto the trailing link and against the right hand tie rod. This totally eliminated the ability to turn to the right and only allowed a very slight but also very difficult turn to the left. This failure if it occurs at an inopportune time and place it could easily be very hazardous. This particular failed part had no rust what so ever but the rate of failure would be increased if rust was present. I would recommend that everyone with a Nash Healey spend some time scraping any excess rubber off of the bottom of the spring seat and sanding any remaining paint off of it and carefully examining the steel at the 90 degree bend with a magnifying glass for cracks. I would also recommend to have them both magnifluxed or check them with a spray on product called Spot Check which will help identify any cracking at the present time.
